# HOOPER BAY AIRPORT IMPROVEMENTS

PROJECT No. 57419

RECONNAISSANCE STUDY, 2005

## RECONNAISSANCE Study Report

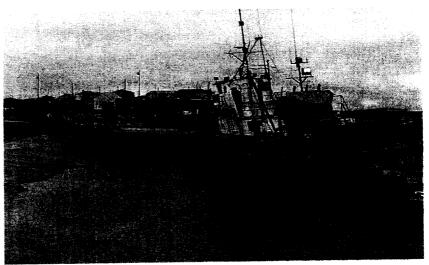
addresses ground transportation concerns and solutions ranging from short to long-range projects. The plan estimates the number of vehicles in the community to include 8 trucks, 250 four wheelers, 300 snowmachines and 300 skiffs. Barge lines deliver shipments of fuel and other bulk supplies throughout the summer as shown in the picture above.

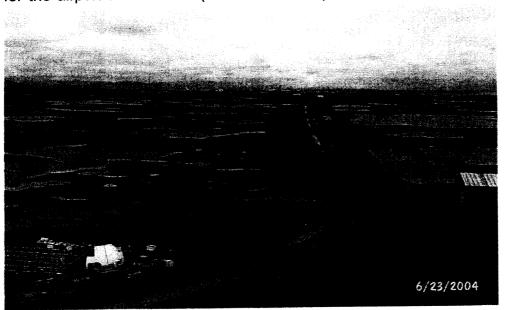
In addition to the runway surfacing, an interim project should also include a stabilized base for the airport access road (as shown below) to withstand recurring flood events. The

airport access road is presently in poor condition and is subject to flood recurring The events. road elevation is approximately 1.5' to 3.5' above mean sea level, while the airport is located on dunes coastal adjacent to the Bering Sea at a higher elevation of approximately

9'. According to locals, the area can be inundated with up to four feet of standing water. In addition to the flooding, the access road also experiences significant wear from

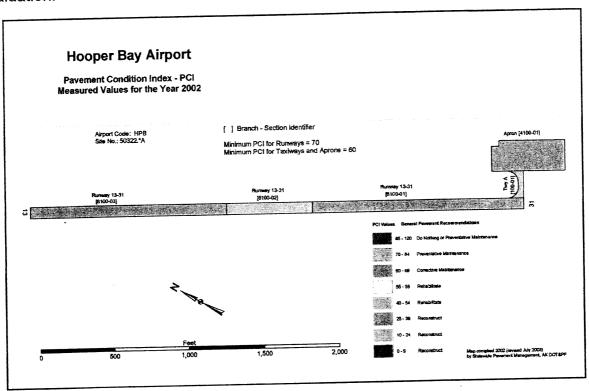
The runway, taxiway and apron were evaluated in 2002 using the Corps of Engineers Pavement Condition Index (PCI). The graphic shown on the next page summarizes the evaluation.

A perfect, new pavement has a PCI value of 100. Deductions are made for measured pavement distresses so that a completely failed pavement would have a PCI of 0. As indicated in the 2003 PCI report, the average weighted runway PCI for Hooper Bay was 31, while the taxiway and apron scored a 28. As previously shown, all existing pavement falls under the "reconstruct" category.

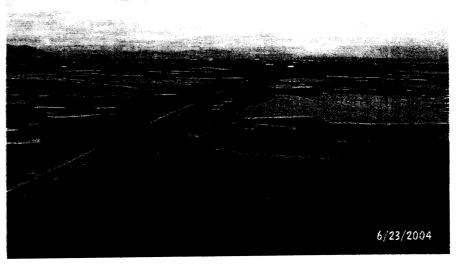
Another immediate concern is the airport access road. The existing road is in use, but is in major need of repair. As shown below, flooding and storm surge events have eroded

nearly all of the useable material from the road, which currently exists as a footprint, with sections below the falling terrain. surrounding Because of these high water events, the interim prohibits the design possibility of building up the road without major erosion protection. For an interim project, this would prove quite costly to construct and difficult to maintain. Because of these concerns it is

recommended that the interim project place 1.5' of medium sized aggregate (3" - 8") to provide a shallow solid base that will be resistant to flooding erosion. The low profile will still allow high water events to pass over the road, but will remain in place after the event.

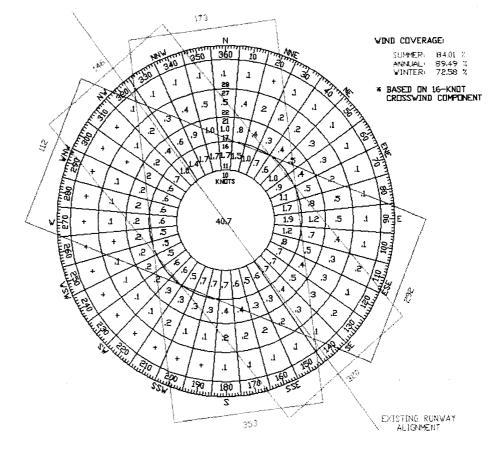
data Wind was collected from the Hooper Bay automated weather observation station (AWOS) and was obtained through the National Climatic Data Center. The data included wind velocity and direction observations at 1intervals hour between January 1994 and December Using this 2003. data, wind analyses were performed for runway orientations in accordance with 150/5300-13. AC Appendix 1. The wind rose shown the depicts

annual data overlain with optimized summer (May – October), winter (November – April) & annual orientations (12 month composite).

A 16-knot crosswind component was used for all analyses to accommodate the ultimate B-III design group. The optimized heading based on true north was analyzed using summer, winter & annual wind observations to determine if there was significant seasonal variance. As indicated in the wind rose, the seasonal orientations vary by 61°. It should also be noted that the orientation based on the annual data falls below the FAA recommendation of 95% coverage. This indicates that a crosswind runway should be evaluated in the ultimate design. Due to the seasonal variance, it is unclear at the time of this report what the optimal orientation will be. This will be decided during the design phase of the project.

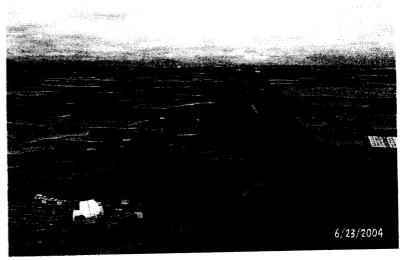
surge events. During a field trip conducted on June 23, 2004, locals commented that the existing airport access road (as shown right) is subject to flooding from these events, which inundate the area with up to four feet of standing water. It was also learned that flooding occurs at least every two years to the extent that the road is impassible from the edge of the city to the airport. However, there is no evidence indicating that the village or airport has

ever flooded. (Note: the elevation of Hooper Bay City is 35' on a USGS quad map, datum WGS84/NAD83.)

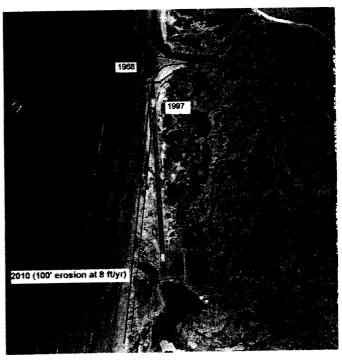
At the apparent erosion rate of 8-feet per year, erosion will have breached the ends of the sheet pile wall in another 7 to 10 years. This is depicted in the graphic shown right. The red line depicts what the beach line would be at the erosion rate of 8 feet/year. If erosion slows to the previous rate of 3 feet per year, we are looking at about 30 years. Either way, this does not provide a 50-year life.

In the event that the airport is reconstructed at its present location, erosion would affect the northwest corner of the safety area within 10 years (if the sheet pile were not in place). To

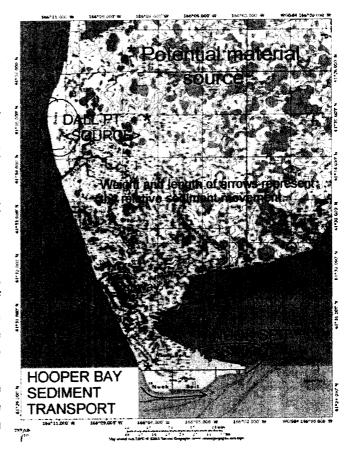
Dall Pt. (as shown right) exhibits characteristics of bi-directional transport of sediment and acts as both a sediment source and sink. Sediment moves both north and south from Dall Pt. This has potential as a material source in the event that the airport is relocated to sites 1 or 2.

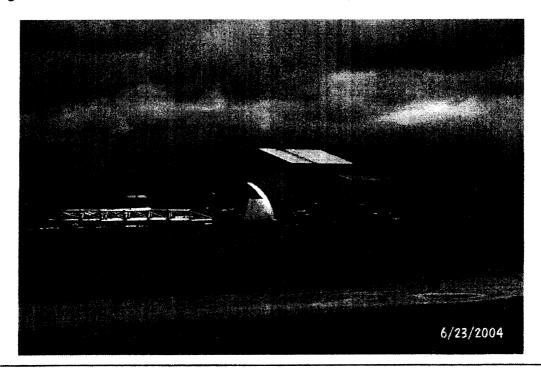
Hooper Bay currently has a 40' x 60' two-bay unheated snow removal equipment building, which is shown in the picture below. The building was built in 1964 and is currently included in the AIP spending plan for replacement. The plan includes a new heated 3-bay building with metal floor, which shall be located on the proposed apron.
